# Metal roof solves asbestos problem

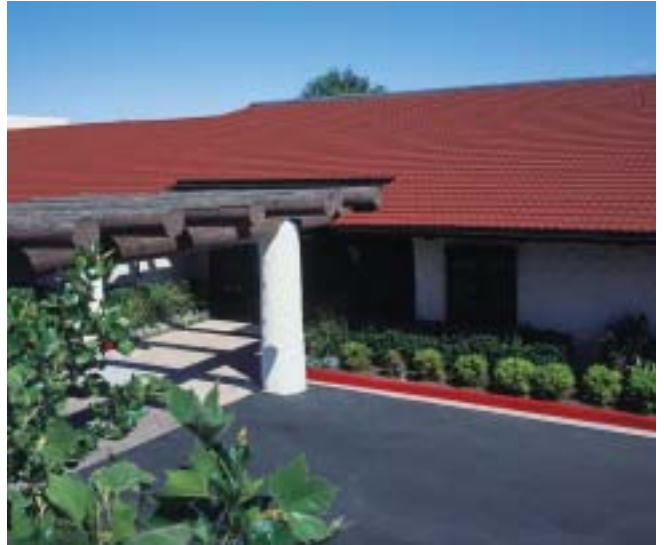
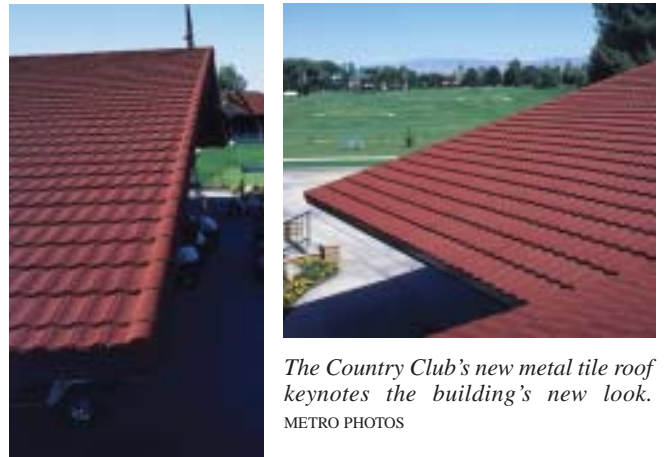
*The Country Club's new metal tile roof keynotes the building's new look.*  
METRO PHOTOS

Wertz showed Zahn Metro Roof Products' stone-coated MetroTile in the Mission Red color and explained why it would be just right for the country club's situation. The material could be applied directly over the existing roof, with no tear-off, solving the asbestos liner problem. The metal material offers a tile look at a fraction of the weight, eliminating the need for engineering analysis or structural reinforcement. The metal panels are also safer in a high-wind environment, with a 50-year warranty covering 120 mph winds.

So did the Metro product's Class 4 hail impact resistance, and 25-year limited appearance warranty. Metro offers the same backing for all its lightweight (1.5 pounds per square foot) stone-coated Zincoalume steel roof systems. They come
